THIRD SUMMARY REPORT  
ON  
STRUCTURAL STUDIES OF BEARING STEEL  
UNDERGOING CYCLIC STRESSING

May 20, 1967

ONR Contract No. Nonr-4433 (00)

RESEARCH LABORATORY  
**SKF INDUSTRIES, INC.**  
ENGINEERING AND RESEARCH CENTER  
KING OF PRUSSIA, PA.

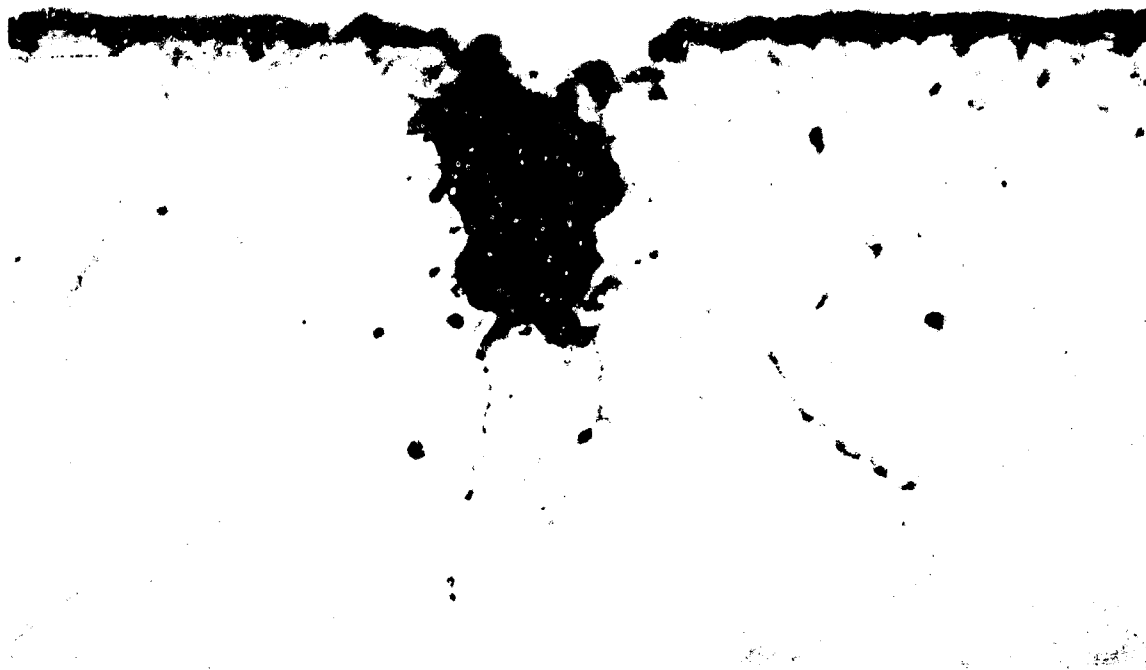
ENCLOSURE 6

The presence of lenticular carbides can therefore be taken as a measure of the time required to produce the adjacent areas of plastic deformation. Thus a distinction can be made between rapidly formed and slowly formed deformation bands. This distinction can be of value when assessing the stress raising potential of a defect or inclusion. Where rapidly formed white areas are seen around a defect it can be concluded that the defect was an effective stress concentrator. Such a defect is shown in Enclosure 6 where rapidly formed deformation bands can be seen around the inclusion.

INCIPIENT SPALL FORMING AROUND A NEAR SURFACE INCLUSION

Cracks associated with the defects and deformation bands.

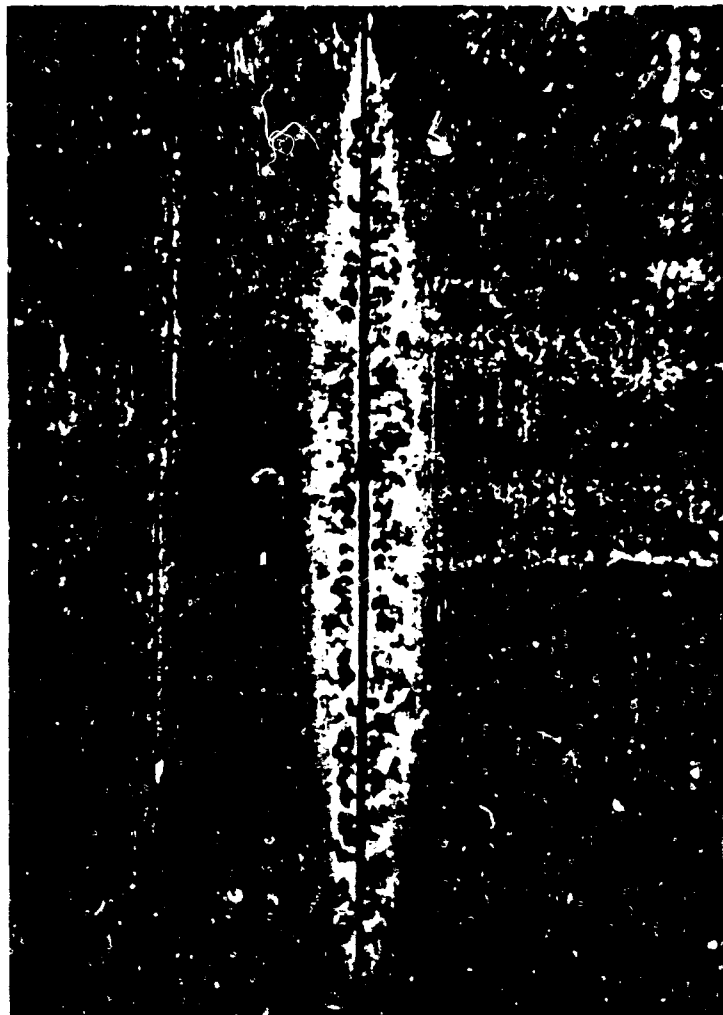
ENCLOSURE 15

SURFACE VIEW OF A GRINDING FURROW ON AN  
ENDURANCE TESTED INNER RING

Surface distress is apparent in the glazed area surrounding  
the furrow after 150 million revs.

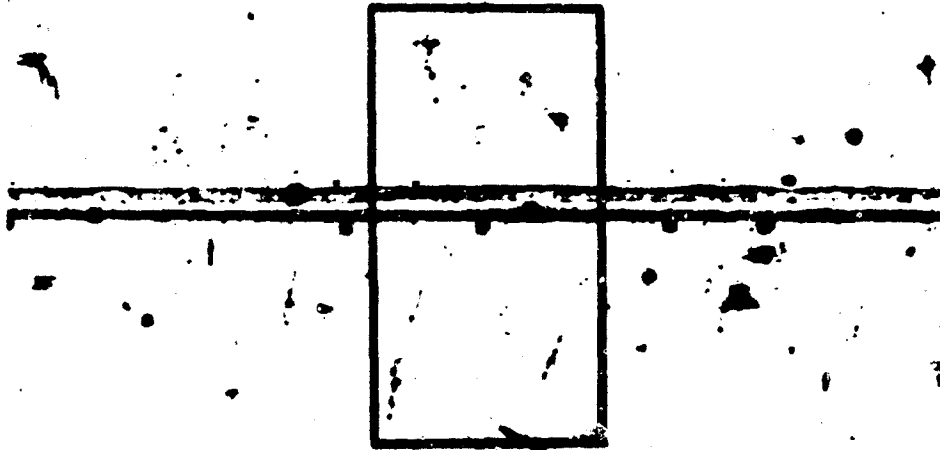
ENCLOSURE 16

SURFACE DISTRESS SIMILAR TO THAT SHOWN IN ENCLOSURE 15

Polishing to a depth of .0001" reveals cracking under the glazed and pitted area which surrounds a furrow.

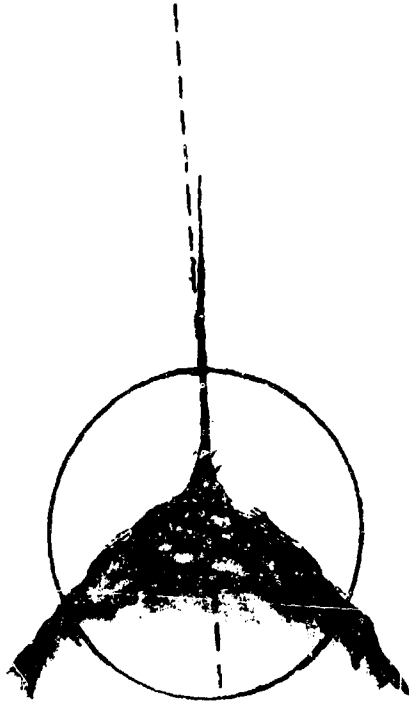
ENCLOSURE 19FULL SCALE SPALL INITIATED AT THE SURFACE BY A GRINDING FURROWRolling Direction  
↓

The elastohydrodynamic oil film, which under the test conditions normally keeps the bearing surfaces separated in the contact area, collapses in the vicinity of the grinding furrow due to oil leakage into the furrow. This allows metal to metal contact to occur at the borders of the furrow, leading to the glazed appearance of Enclosure 15. Heavy tractive forces which greatly intensify the local stress field are presumably generated when the metal surfaces come into contact. The increased stresses cause localized plastic disturbances which in turn leads to cracking as shown in Enclosure 16. The cracks eventually join to form an incipient spall (Enclosure 18) which then grows to become a full scale spall that ends the useful life of the bearing (Enclosure 19).

Furrow Initiated Spall

Circumferential plane showing the area where the grinding furrow leads into the spall. The shallow entry into the spall can be seen to follow the direction of locally produced deformation bands lying near the original contact surface.

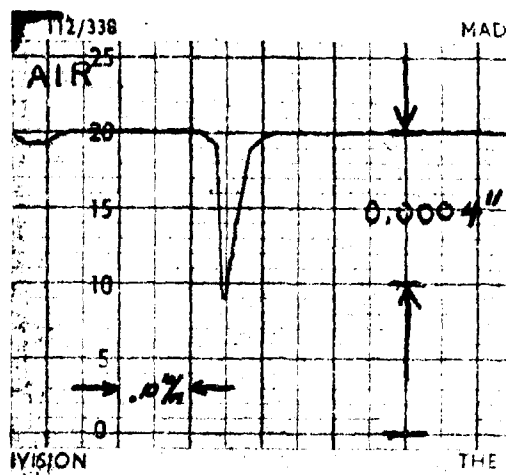
SPALLING AT AN INTENTIONALLY PRODUCED SCRATCH

Intentionally produced scratch running across the groove (perpendicular to the rolling direction) of a bearing inner ring.

Talysurf trace through the scratch shows it to be approximately 0.0004" deep.

Same scratch after the bearing failed. The scratch remains intact with the spall directly behind it, in the rolling direction.
